Filter fences for erosion control in the aftermath of potatoes

Andy Vinten, Kenneth Loades, Stephen Addy, Samia Richards, Marc Stutter, Yvonne Cook, Helen Watson, Carol Taylor, Claire Abel (The James Hutton Institute), Bill Jeffrey, Robert Ritchie (SAC). For more information, please contact: Andy Vinten (andy.vinten@hutton.ac.uk) at James Hutton Institute, Craigiebuckler, Aberdeen AB15 8QH; Tel 0844 928 5428

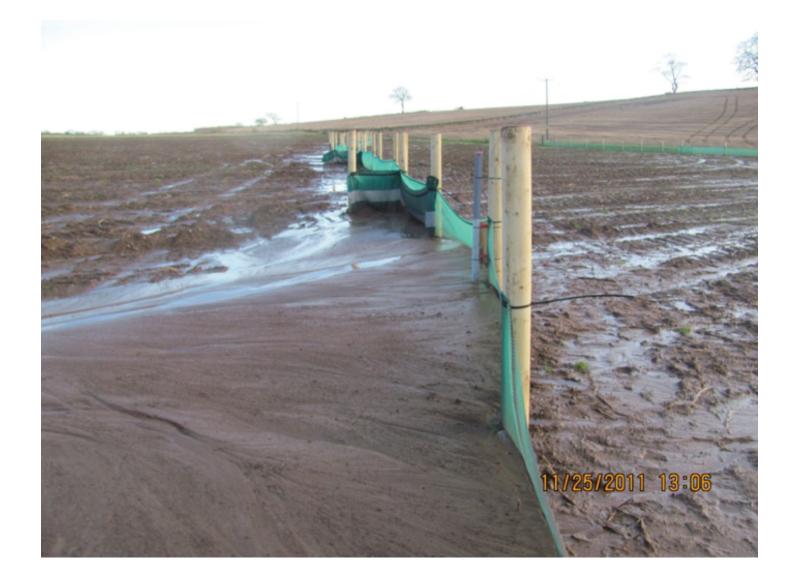
Figure 1 Deposition fan on 25 November 2011 on a filter fence plot with no cultivation upslope. Note the upslope spurs at the edge of each plot, to constrain lateral movement of sediment between plots.

Large volumes of sediment were captured by the filter fences (Figure 1).
